**State of Louisiana
Coastal Protection and Restoration Authority**

2017 Annual Inspection Report

Barataria Bay Waterway East Shoreline Protection

State Project Number BA-26
Priority Project List 6

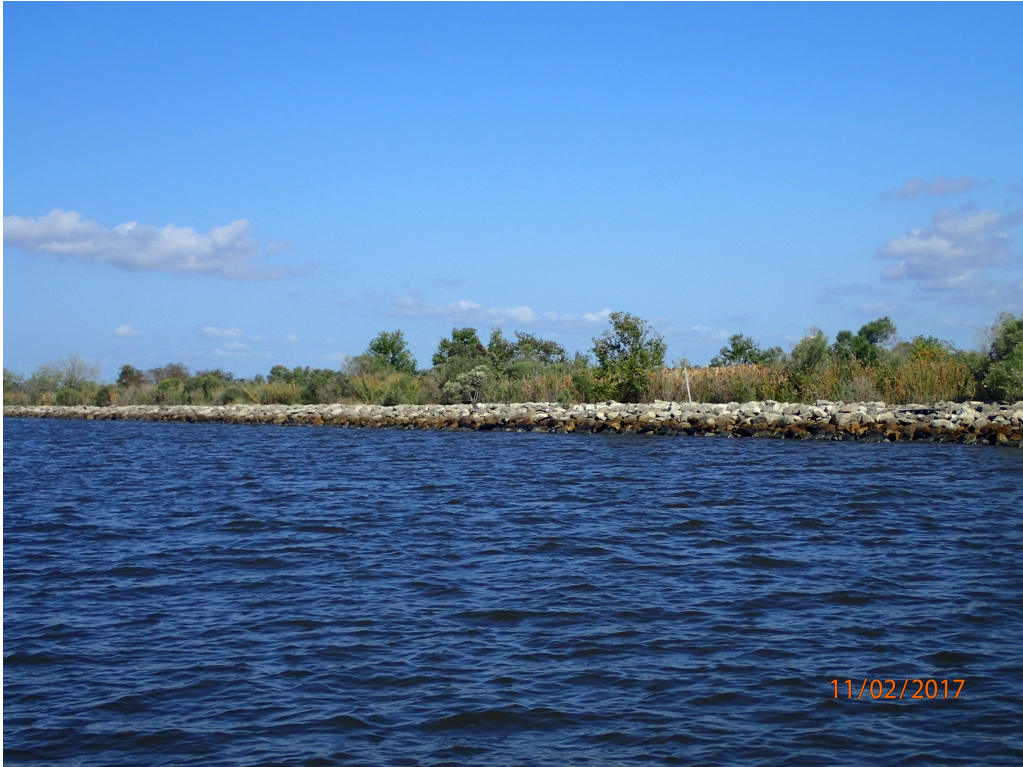
Overall, the rock shoreline structure was in good condition (Photo #1). Some portions of the rock structure adjacent to and south of the BA-41 marsh creation area have experienced settlement (Photos #2 & #3). Accretion and vegetation were observed behind the rock structure at the northern end of the project (Photo #4).

Photo #1 – Shoreline protection rock structure

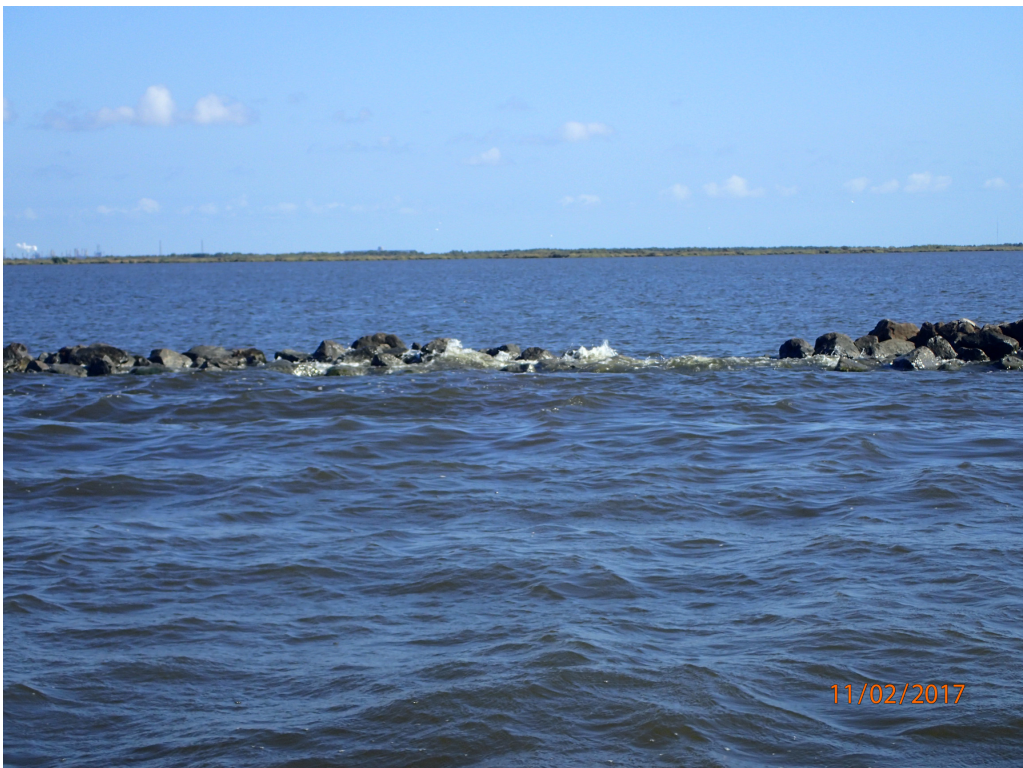
The Barataria Bay Waterway East Protection Project (BA-26) is performing adequately. The rock dike is protecting the existing marsh as designed. Settlement has been noted in some areas which may require corrective action in the near future.

Photo # 2 – Settlement noted in open water area

To determine if a maintenance rock lift is warranted and to help determine a path forward involving end of life, CPRA recommends performing a professional survey to assess and document the top-of-rock elevations in the areas which appear to be experiencing settlement. Additional recommendations will be presented to NRCS following the collection and assessment of survey data.

- Perform a survey of the rock dike to determine their status as we move toward the End of Project Life.

- CPRA will perform a survey check of the low rock areas.

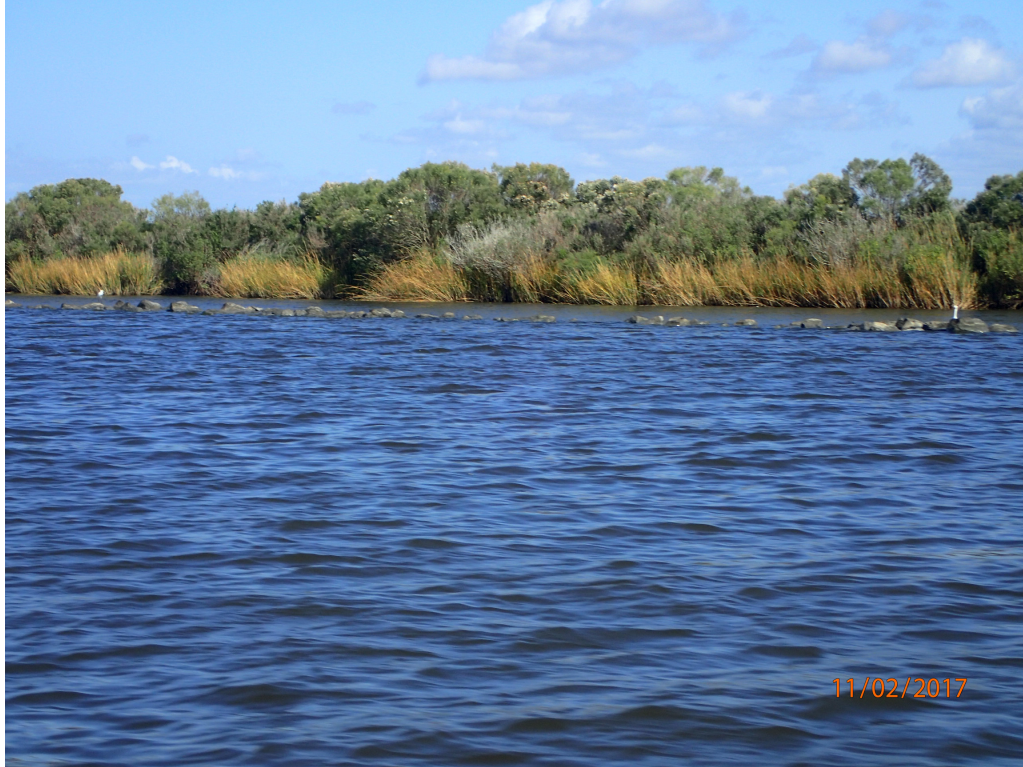
Photo # 3 – Settlement noted west of BA-41 marsh creation area

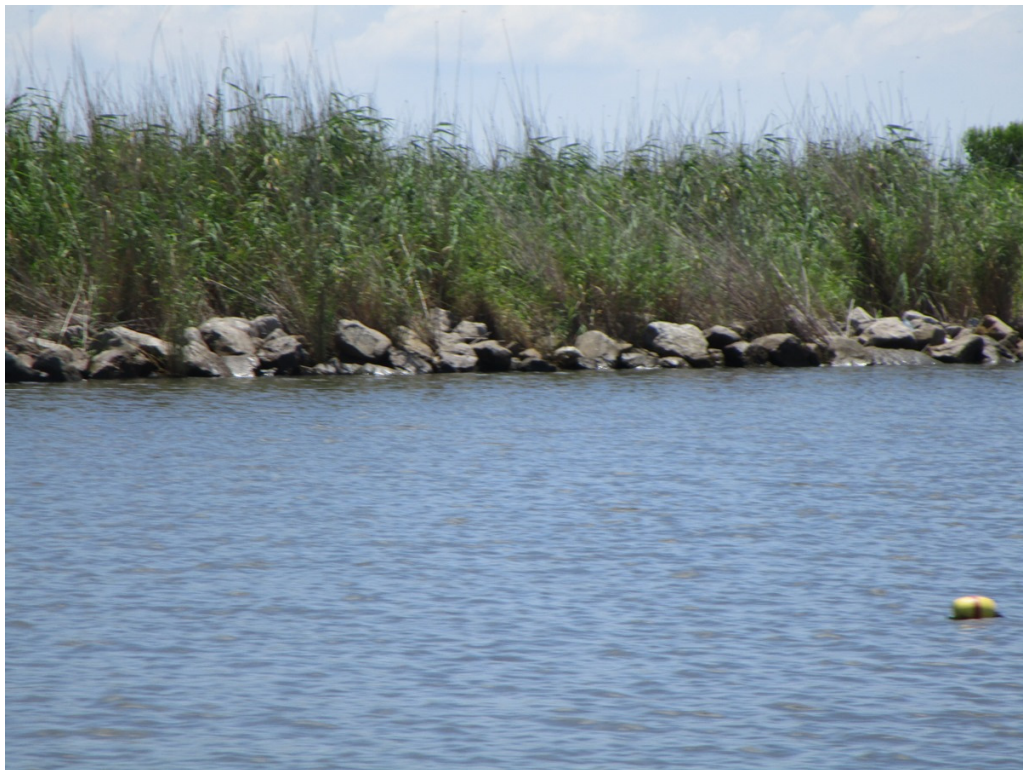
Photo # 4 – Accretion & vegetation behind the rock structure
